NDI No. PA 00208  
PENN DER No. 26-70

FAIRCHANCE RESERVOIR DAM  
BOROUGH OF FAIRCHANCE

PHASE I INSPECTION REPORT  
NATIONAL DAM INSPECTION PROGRAM

APRIL 1980

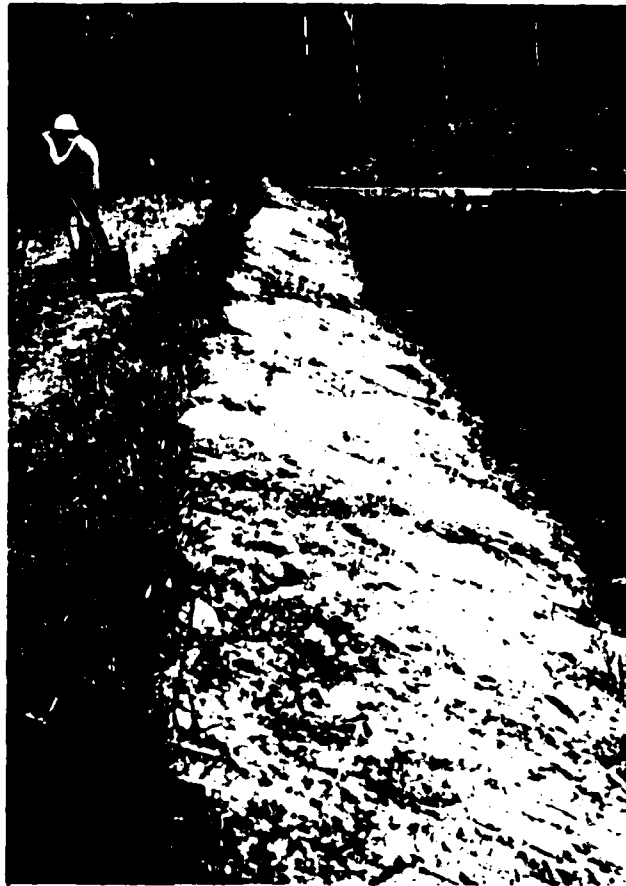
(2) Upstream Slope: The upstream slope was entirely covered by cemented riprap, which contained minor cracks and a small amount of vegetation growing. The slope protection was in good condition.

PHOTO 1. VIEW OF EMBANKMENT, CEMENTED  
RIPRAP, AND SPILLWAY TRAINING WALL

(d) Repair cracks in the spillway walls, slab and weir and in the cemented riprap on the upstream slope.

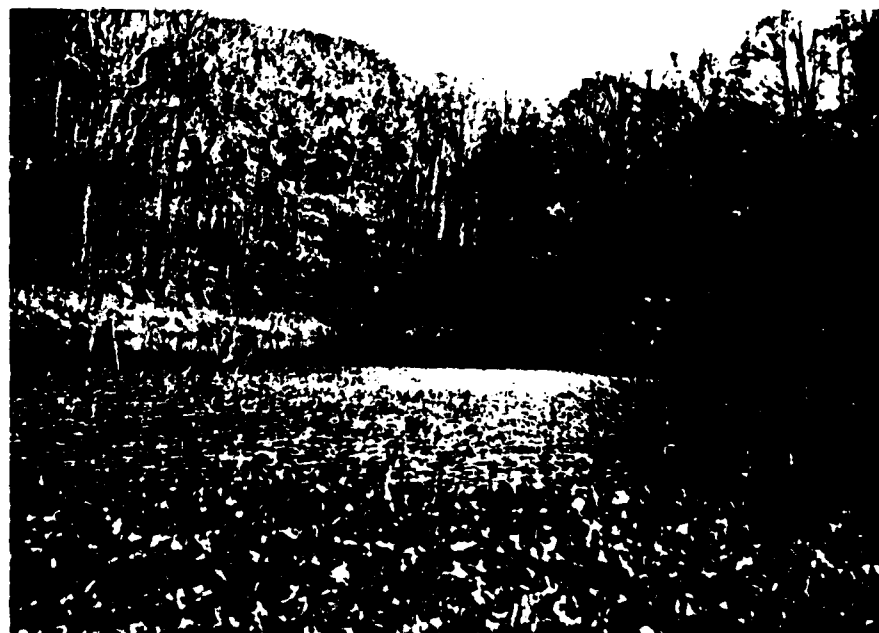
(1) Shoreline: The reservoir shoreline was observed to be generally steep and densely wooded. No bank erosion or instability was observed.

PHOTO 2. OVERVIEW OF RESERVOIR

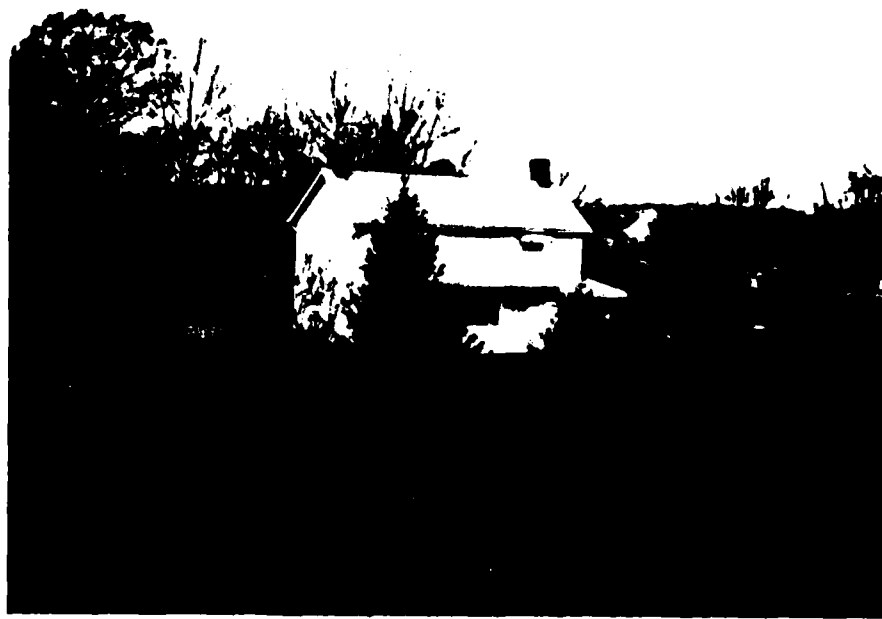
d. Hazard Classification: Fairchance Reservoir dam is classified as a "high" hazard dam. In the event of a dam failure, numerous inhabited dwellings, and considerable commercial development on the floodplain below the dam would be subjected to substantial damage and loss of life could result.

PHOTO 12. INHABITED RESIDENCE DOWNSTREAM OF DAM
